**Flood Control Project Maintenance  
Levee Inspections**

**Fall 2019 Levee Maintenance Deficiency Summary Report**

**Sacramento River Basin**

**Sacramento Maintenance Yard Maintenance Area 0009**

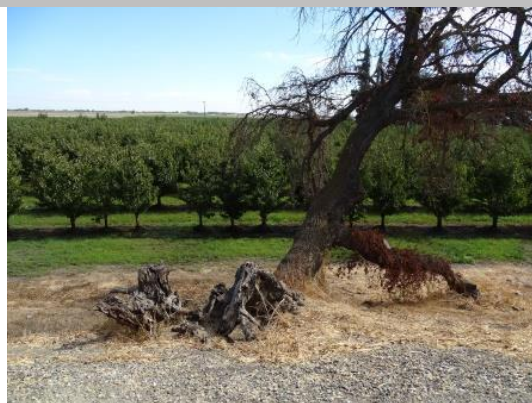
Photo 1 of 1 : FA\_2019\_MA0009\_201\_489\_20190904\_00288.jpg

LM Start	18.70	Rating **	M	Issue No.	489
LM End	18.70	Issue Type +	Ma	Location *	LS
Category	Earthen Levee			GPS Latitude/Longitude	
				Start	End
Item	Encroachments			38.354208 °	38.354208 °
				-121.528808 °	-121.528808 °
DWR ID	DWR_MA0009_01_f_2018_489				
Comment Code					
TR : Tree or limb					
Inspector Comment					
Fallen tree needs to be removed.

View of fallen tree near levee toe. Fall 2018

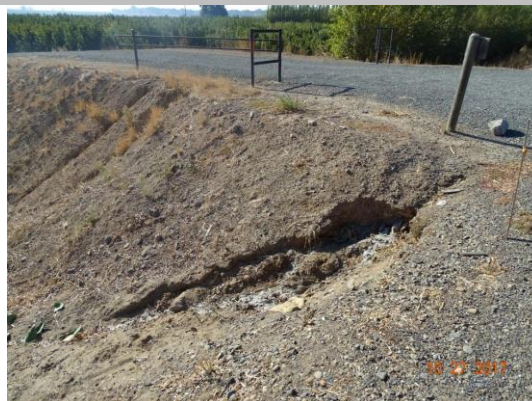
Photo 1 of 1 : FA\_2019\_MA0009\_201\_437\_20190904\_00284.jpg

LM Start	18.84	Rating **	M	Issue No.	437
LM End	18.84	Issue Type +	Ma	Location *	LS
Category	Earthen Levee			GPS Latitude/Longitude	
				Start	End
Item	Erosion / Bank Caving			38.352528 °	38.352528 °
				-121.530385 °	-121.530385 °
DWR ID	DWR_MA0009_01_f_2017_437				
Comment Code					
E2 : Schedule repair of erosion site prior to the next inspection.					
Inspector Comment					
Repair runoff erosion on landside slope and access ramp.

View of erosion on landside slope and ramp. Fall 2017.

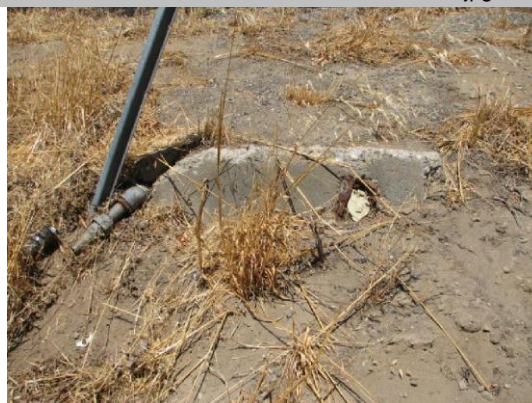
Photo 1 of 3 : UCIP\_FA\_2019\_5780\_8743.jpg

Comment Code						
Inspector Comment						
DS_ID:17554						
FS_ID:5780						
EP_NO: 6001						
Repair Type: Non-Urgent						
Crossing Status: Found						
UCIP Comments: Black PVC pipe on LS shoulder not connected to 3-inch pipe through the levee and there is no shutoff valve.						
FIELD_STRUCT_DESC: 3-inch galvanized iron drainage pipe through the levee, 3 feet below the crown. Concrete boxes on both ends of the pipe. Steel sign post on the landside (LS) shoulder marks concrete box. Black polyvinyl chloride (PVC) pipe runs up the LS slope to concrete headwall and connection to 3-inch pipe. 3.5-inch white PVC pipe runs down the waterside (WS) slope within a corrugated metal sluice.						
Electrical connection also noted on headwall. (Permit No. 6001, 1968 - Peter D. Scatena). Minor design drawings available in permit.						
FS Date: 7/25/2012 2:58:03 PM

Concrete headwall on LS slope showing 3-inch pipe, electrical conduit, and sign post.

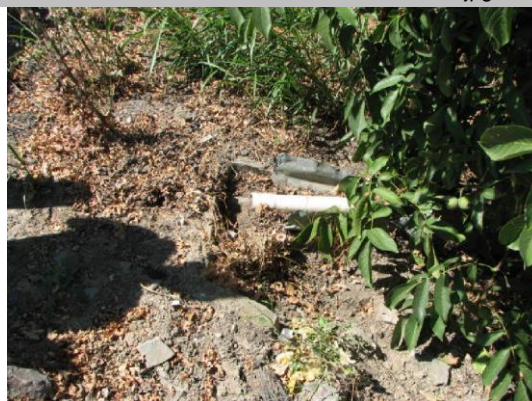
Photo 2 of 3 : UCIP\_FA\_2019\_5780\_8742.jpg

Concrete U shaped headwall at outlet showing white PVC pipe in corrugated metal sluice on WS shoulder.

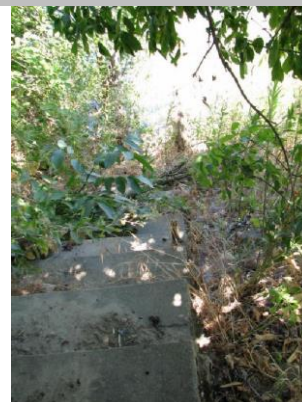
Photo 3 of 3 : UCIP\_FA\_2019\_5780\_8741.jpg

Concrete stairs on WS slope just upstream from pipe crossing.

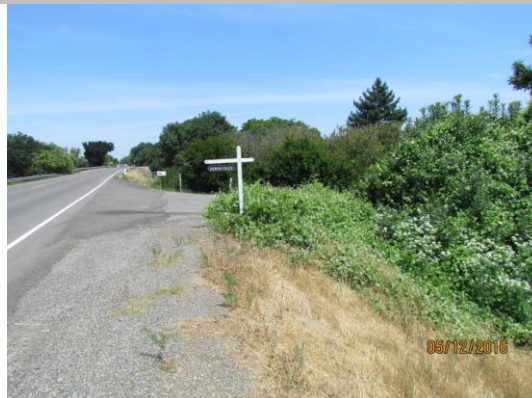
Photo 1 of 1 : FA\_2019\_MA0009\_201\_194\_20190904\_00121.jpg

LM Start	18.95	Rating **	M	Issue No.	194
LM End	18.95	Issue Type +	En	Location *	LS
Category	Earthen Levee			GPS Latitude/Longitude	
				Start	End
Item	Vegetation			38.351293°	38.351293°
				-121.531639°	-121.531639°
DWR ID	DWR_MA0009_01_s_2012_194				
Comment Code					
V6 : Landscaping					
Inspector Comment

View of the shrubs on the landward side of the levee looking upstream. Spring 2016.

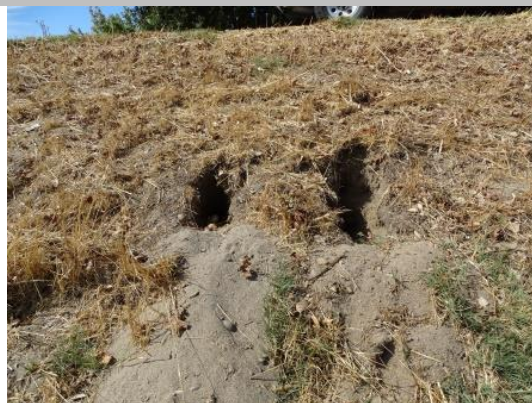
Photo 1 of 2 : FA\_2019\_MA0009\_201\_487\_20190904\_00286.jpg

LM Start	19.01	Rating **	A/W	Issue No.	487
LM End	19.01	Issue Type +	Ma	Location *	LS
Category	Earthen Levee			GPS Latitude/Longitude	
				Start	End
Item	Animal Control			38.350600 °	38.350600 °
				-121.532409 °	-121.532409 °
DWR ID	DWR_MA0009_01_f_2018_487				
Comment Code					
A3 : No rodents visible, but rodent burrows visible; need to backfill and compact or grout burrows.					
Inspector Comment					
LMA backfilled animal burrows.

View of recent rodent burrows. Fall 2018

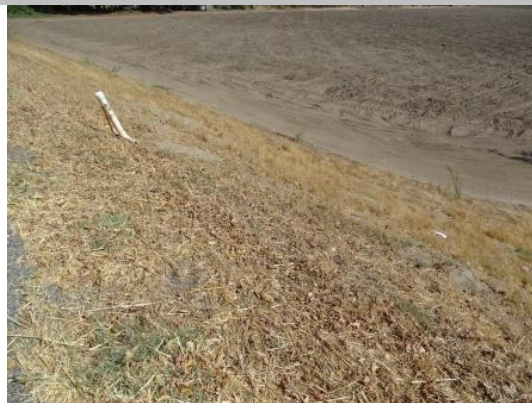
Photo 2 of 2 : FA\_2019\_MA0009\_201\_487\_20190904\_00287.jpg

View of rodent activity. Fall 2018

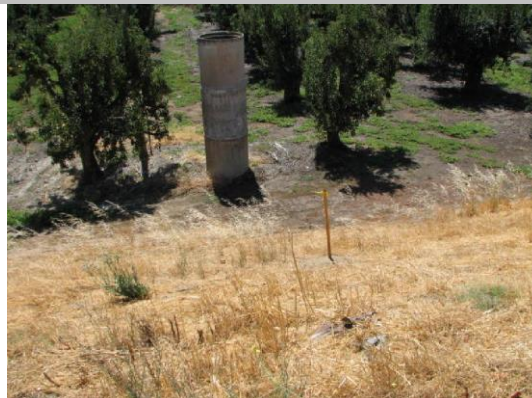
Photo 1 of 3 : UCIP\_FA\_2019\_5783\_8754.jpg

Comment Code						
Inspector Comment						
DS_ID:17451						
FS_ID:5783						
EP_NO: N/A						
Repair Type: Non-Urgent						
Crossing Status: Found						
UCIP Comments: Oil leaking all over pump platform and ground around pump. CMP riser on LS slope is damaged and should be marked to prevent further damage of siphon breaker and roadway equipment.						
FIELD_STRUCT_DESC: 12-inch pipe through levee, 4.5 feet below crown. Slant Pump on pile structure on WS slope. Siphon breaker on landward slope. 1.5-inch galvanized electrical conduit 4.5-feet below the crown from JP on LS toe to Breaker on slant pump pier. 36-inch Concrete standpipe on LS toe. One cm cutoff wall. Originally included in O+M manual (1955).						
FS Date: 7/25/2012 3:15:00 PM

36-inch concrete standpipe on LS toe.

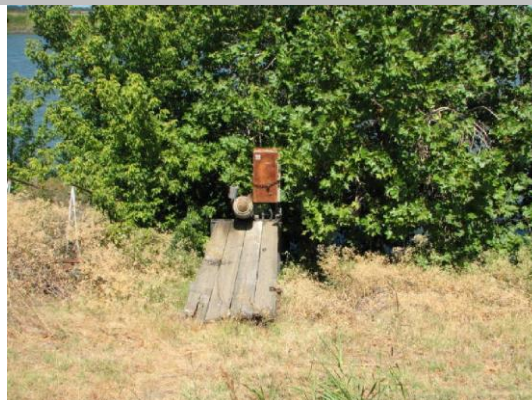
Photo 2 of 3 : UCIP\_FA\_2019\_5783\_8753.jpg

Slant pump on Pile structure WS slope.

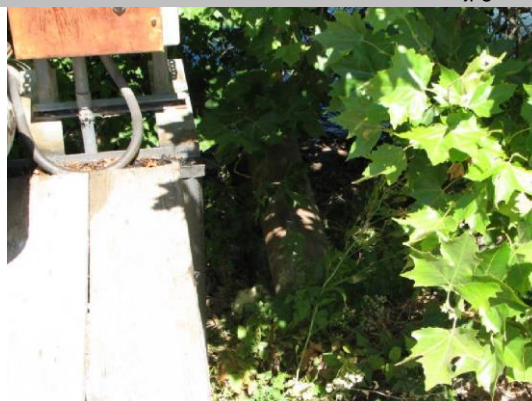
Photo 3 of 3 : UCIP\_FA\_2019\_5783\_8752.jpg

Item	DRAFT DWR UCIP Field Study		38.350460 °	38.350460 °								
			-121.532600 °	-121.532600 °								
DWR ID	17451											
Comment Code												
Inspector Comment												
DS_ID:17451 FS_ID:5783 EP_NO: N/A Repair Type: Non-Urgent Crossing Status: Found UCIP Comments: Oil leaking all over pump platform and ground around pump. CMP riser on LS slope is damaged and should be marked to prevent further damage of siphon breaker and roadway equipment. FIELD_STRUCT_DESC: 12-inch pipe through levee, 4.5 feet below crown. Slant Pump on pile structure on WS slope. Siphon breaker on landward slope. 1.5-inch galvanized electrical conduit 4.5-feet below the crown from JP on LS toe to Breaker on slant pump pier. 36-inch Concrete standpipe on LS toe. One cm cutoff wall. Originally included in O+M manual (1955). FS Date: 7/25/2012 3:15:00 PM

Pipe below structure on upstream side of slantpump.

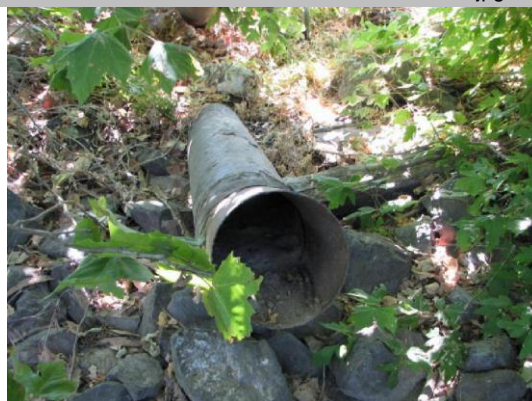
Photo 1 of 3 : UCIP\_FA\_2019\_53481\_20818.jpg

Comment Code						
Inspector Comment						
DS_ID:17579 FS_ID:53481 EP_NO: N/A Repair Type: Urgent Crossing Status: Found UCIP Comments: 08/24/2018 Pipe open on both ends. Excavation damaged the LS toe. LS end of the pipe has been dug up, and the LS riser and standpipe have both been removed. Electrical conduit visible where the LS pipe was dug up. Crossing remains "Urgent" due to a cut on the LS toe. (A. McDonald - DWR UCIP)12/02/2016 same as last inspection. Owner will need to coordinate with CVFPB to comply with Title 23. Crossing remains "Urgent" due to pipe being opened on both WS and LS. (O. Magana - DWR UCIP)07/25/2012 This pipe has been abandoned improperly as it is open on the WS (it should be grouted in place or removed. Original slant pump piping and walkway are still visible on WS slope and may need to be removed. (W. Wylie - DWR UCIP) FIELD_STRUCT_DESC: *ABANDONED* 12-inch steel irrigation pipe through the levee, 6.5 feet below the crown. This pipe is located 2 feet below the 12-inch pipe currently in use (2012). Pipe originally included in USACE O&M Manual (1959) as a 10-inch pipe. Pipe open on both ends, excavation damaged the LS toe, LS end of pipe dug up, and LS riser and standpipe removed, August 2018. Electrical conduit visible where the LS pipe was dug up. [Additional Reference(s): DWR Levee Log, 1991. USACE Sacramento O&M Manual Unit 111, May 1959 (Station 36.88)]. FS Date: 8/24/2018

12-inch abandoned pipe open on WS.

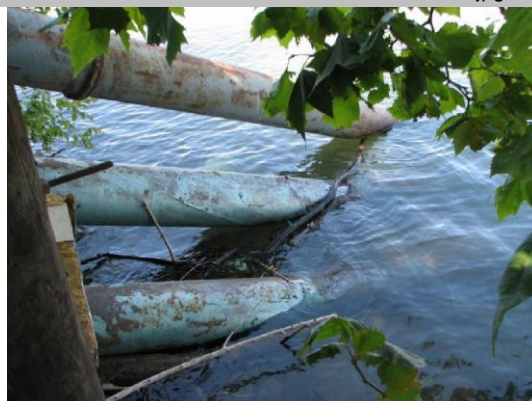
Photo 2 of 3 : UCIP\_FA\_2019\_53481\_20817.jpg

3-separate suction pipes on WS slope. All but one abandoned and left open.

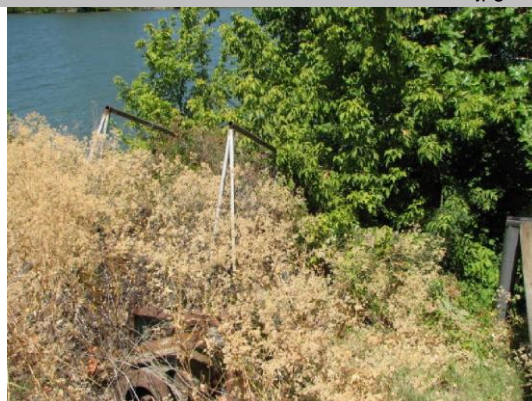
Photo 3 of 3 : UCIP\_FA\_2019\_53481\_20816.jpg

Discarded metal walkway ramp and slant pump appurtenances on WS slope.

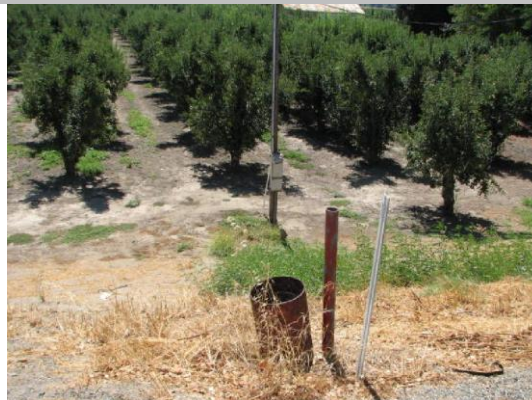
Photo 1 of 3 : UCIP\_FA\_2019\_5943\_9076.jpg

Comment Code						
Inspector Comment						
DS_ID:17477						
FS_ID:5943						
EP_NO: N/A						
Repair Type: Non-Urgent						
Crossing Status: Found						
UCIP Comments: This pipe is a good candidate for video inspection. headwall is cracked and generally looking in poor repair. This may need some work.						
FIELD_STRUCT_DESC: 10-inch pipe through levee, 3.0 feet below crown. Pump on concrete pad waterward slope with a siphon breaker in a 12-inch steel riser on the LS shoulder and a shutoff valve on the WS shoulder. Service pole on landward slope. Originally included in O+M manual as a 3-inch pipe(1955).						
FS Date: 7/25/2012 3:45:00 PM

Siphon breaker on LS shoulder with JP and meter on LS toe.

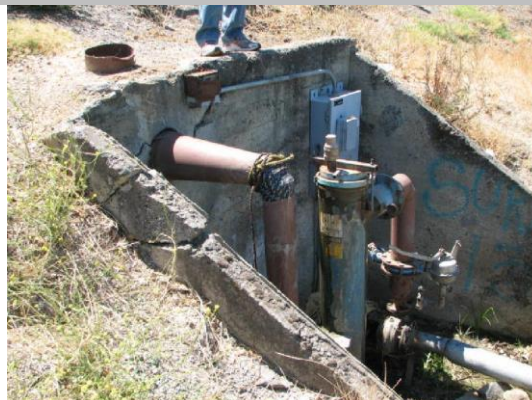
Photo 2 of 3 : UCIP\_FA\_2019\_5943\_9075.jpg

Pump on Concrete pad WS slope. meter and valve on headwall.

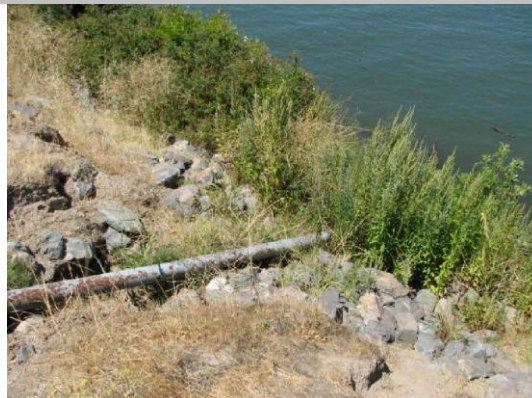
Photo 3 of 3 : UCIP\_FA\_2019\_5943\_9074.jpg

Item	DRAFT DWR UCIP Field Study			38.349330 °	38.349330 °	
				-121.533830 °	-121.533830 °	
DWR ID	17477					
Comment Code						
Inspector Comment						
DS_ID:17477						
FS_ID:5943						
EP_NO: N/A						
Repair Type: Non-Urgent						
Crossing Status: Found						
UCIP Comments: This pipe is a good candidate for video inspection. headwall is cracked and generally looking in poor repair. This may need some work.						
FIELD_STRUCT_DESC: 10-inch pipe through levee, 3.0 feet below crown. Pump on concrete pad waterward slope with a siphon breaker in a 12-inch steel riser on the LS shoulder and a shutoff valve on the WS shoulder. Service pole on landward slope. Originally included in O+M manual as a 3-inch pipe(1955).						
FS Date: 7/25/2012 3:45:00 PM

suction pipe on WS slope.
